Federal Highway Bridge Program Project Application

Replace portion of superstructure due to aging girders.

BOMBING RANGE ROAD BRIDGE COMMENTS

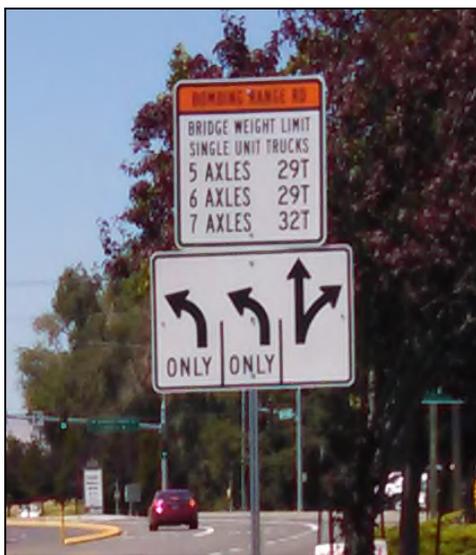
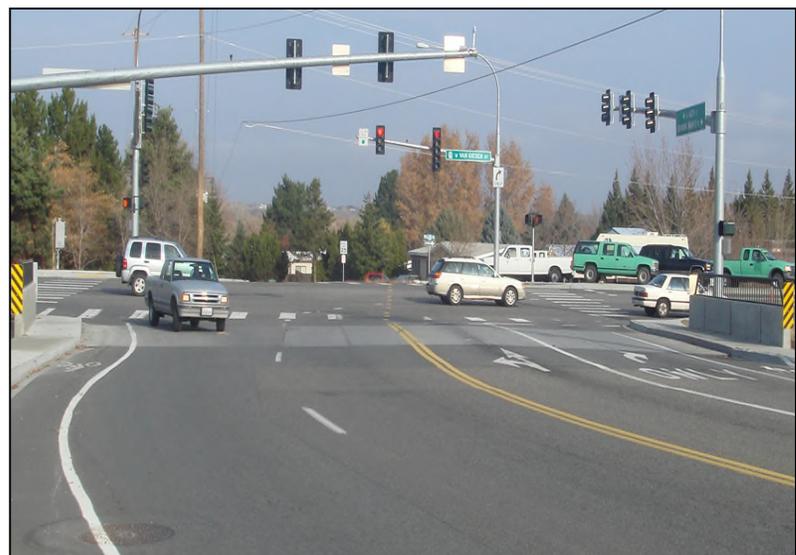
The Bombing Range Road Bridge was originally constructed in 1990 with pre-stressed concrete ribdeck girders. The bridge is located at the intersection of Bombing Range Road and SR 224. This busy intersection provides access to a rapidly growing area of the City. Bombing Range Road is the only major north – south arterial through the City of West Richland with SR 224 being the main access through the City center. The City of West Richland has dramatically grown since the construction of the bridge and continues to be one of the fastest growing areas in the State. With this growth the bridge has seen a significant increase in traffic through the years. Between 2015 and 2016 there has been a 30% increase in traffic with a 3% increase in truck traffic. The bridge has been widened twice from its originally constructed width of 36 feet to nearly 75 feet on the north end and approximately 70 feet on the south end.

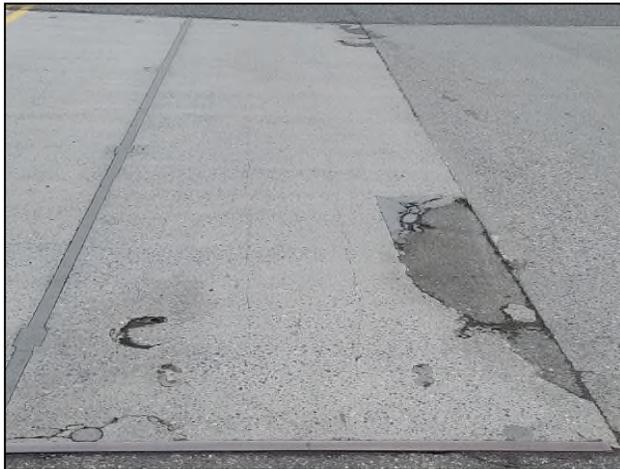
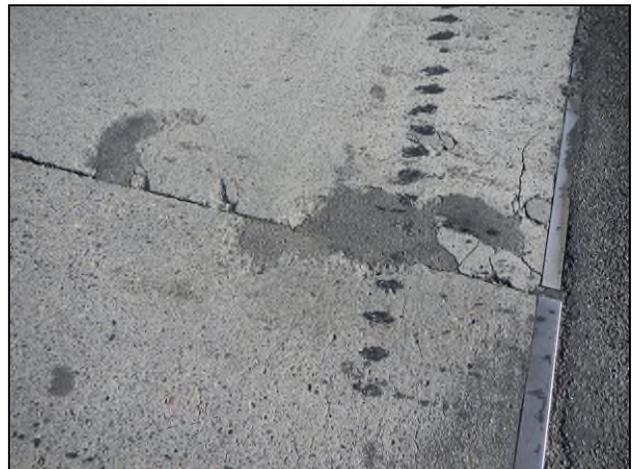
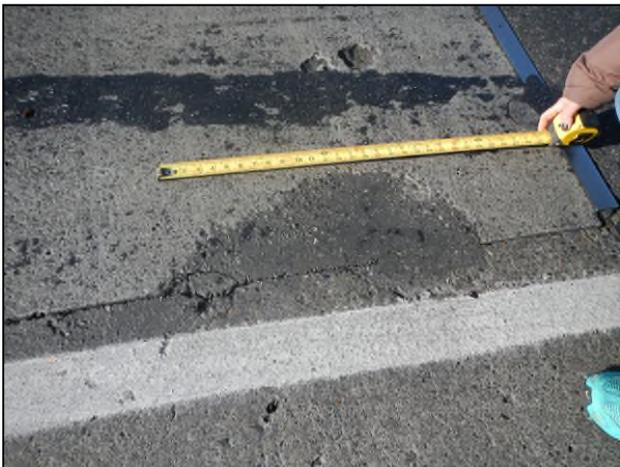
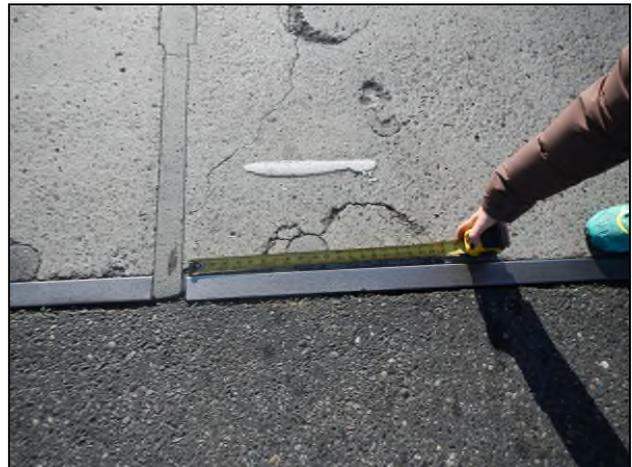
The bridge deck is in “Poor” condition. There are multiple failing patches, spalls, delaminations, and longitudinal cracking in the original ribdeck portion of the bridge deck. The ribdeck girders provide 1008 ft² of deck area, with at least 25 ft² of the deck containing patches, spalls, and/or delaminations. This 2.5% deterioration requires an NBI Deck Condition Code of “4”. The high traffic volume on the bridge has resulted in the existing repairs and patches to repeatedly fail, providing a rough transition through this intersection.

A major concern of the City is the ribdeck portion of the deck. The ribdeck does not have a wearing surface over the ribdeck girders with the girders having only a thin structural deck section of 4-inches. The spalling, patches, and delaminations are occurring directly in the top flange of the girders. While it is unknown how deep the current patches are, they are not structural in nature, meaning that the structural deck support is even less than 4 inches in these patched areas. This is not a long-term situation for this busy intersection, now carrying over 12,000 vehicles per day.

The proposed rehabilitation project would remove the six existing 6-foot-wide ribdeck girders and replace them with nine newly-fabricated 4-foot wide prestressed concrete solid slab girders. A composite concrete deck with epoxy rebar would top the new girders as the new wearing surface, allowing for decades of service life to the center portion of the bridge.

The existing concrete abutments would be utilized with some modification, and the newer portions of the widened bridge would remain in place. Rehabilitation of this bridge would eliminate the issues with the deteriorating bridge deck, and allow the bridge to carry all legal loads. For the existing concrete deck that is to remain, a new concrete overlay will be placed to extend its lifespan.
